# **HOLIDAY INN EXPRESS, WIMBLEDON**

*Geotechnical and Geoenvironmental  
Interpretive Report*

*Ref. CGL-10060B-GGIR-0001-P00*

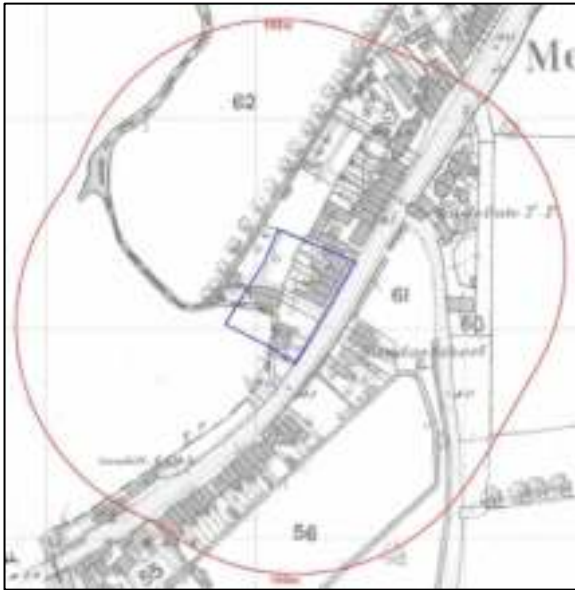
Plate 1. 1866 Historical OS Map of the Site

The earliest available mapping dated 1866 indicates the footprint of the Holiday Inn Express was occupied by residential dwellings with a tributary of the River Wandle running through; what is known in the present day as Wandle Park and south through the centre of site (Plate 1). At this time the *High Street* mapped running northeast southwest was in the same position as found at present day. Within 100m of the site in 1866, the surrounding area was predominantly open space with a *Sunday School* to the south and a *Public House* to the north.

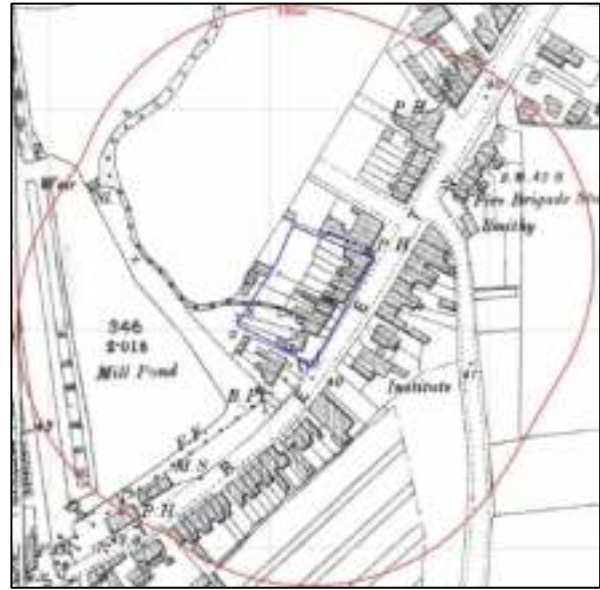
Plate 2. 1896 Historical OS Map of the Site

By 1896, mapping of the site shows some increased development along the *High Street* and surrounding area (Plate 2). A neighbouring *Public House* is mapped north of the site understood to be the present-day Charles Holden pub. Within 100m, northeast of site where the present-day Colliers Wood Underground Station is located, a *Fire Brigade Station* and *Smithy* are both mapped. Further from site, approximately 250m to the southwest the *Merton Abbey Paper Mill* and *Print and Tapestry Works* are also recorded.

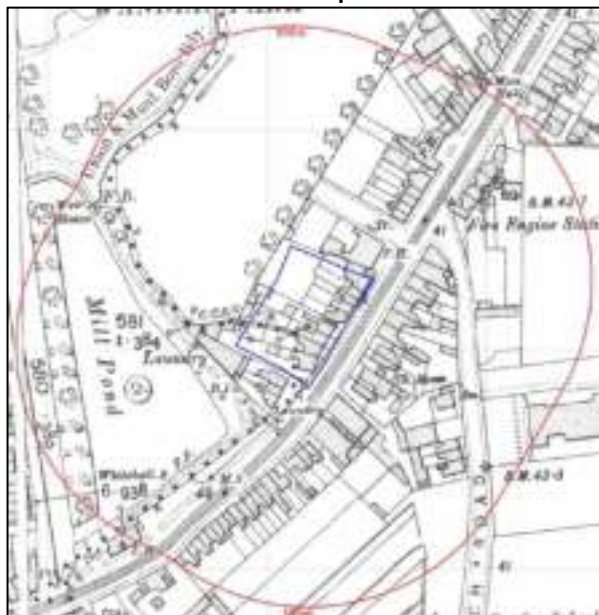
Plate 3. 1913 Historical OS Map of the Site

In 1913, residential development continues to expand in the wider area however development in proximity to the site is largely the same with exception of the neighbouring buildings to the southwest and those on the south side of the *High Street* now described as a *Laundry* (Plate 3).

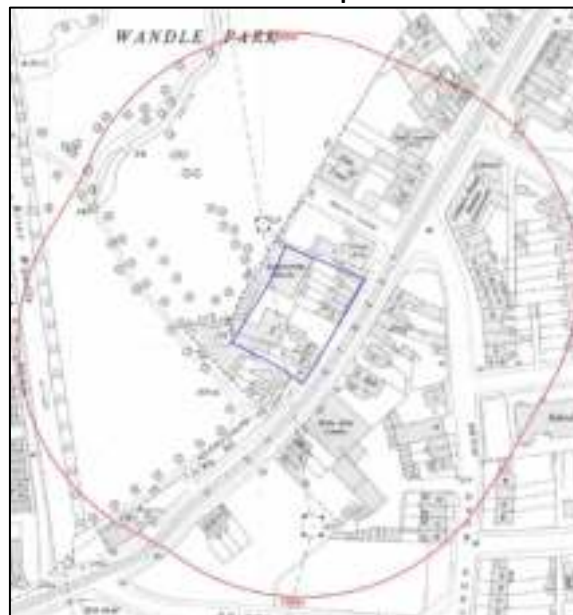
Plate 4. 1950 Historical OS Map of the Site

In 1950 the most relevant development to the site would be the *Engineering Works* mapped within the present-day Holiday Inn Express footprint in the northern corner of site (Plate 4). In addition to the *Engineering Works*, the 1950 map notes a *Tank* just outside of the western boundary of site although the type and contents are unknown.

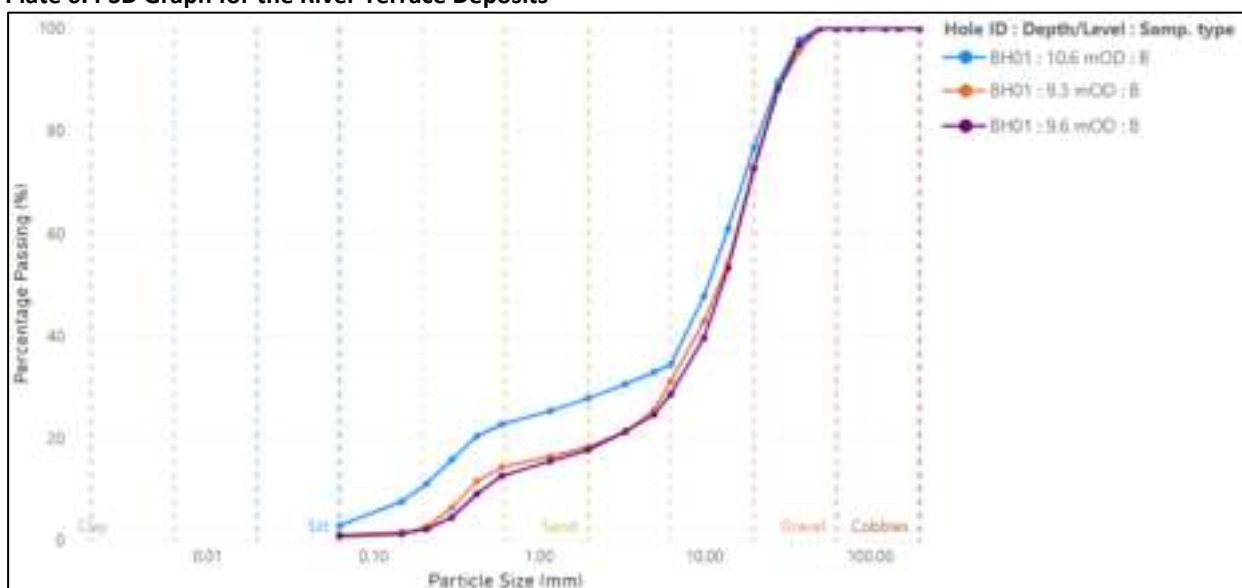
**Plate 6. PSD Graph for the River Terrace Deposits**

The River Terrace Deposits were encountered at a depth of 0.9m (10.94mOD) within Borehole BH01 and between 2.5m (9.38mOD) and 2.8m (9.13mOD) in the window sample boreholes (WS01 and WS02). The base of the River Terrace Deposits contacting the underlying London Clay was found to be at between 2.85m (9.03mOD) and 4.30m (7.63mOD). However, in BH01, the base of the River Terrace Deposits was found to be at 3.10m (8.74mOD).

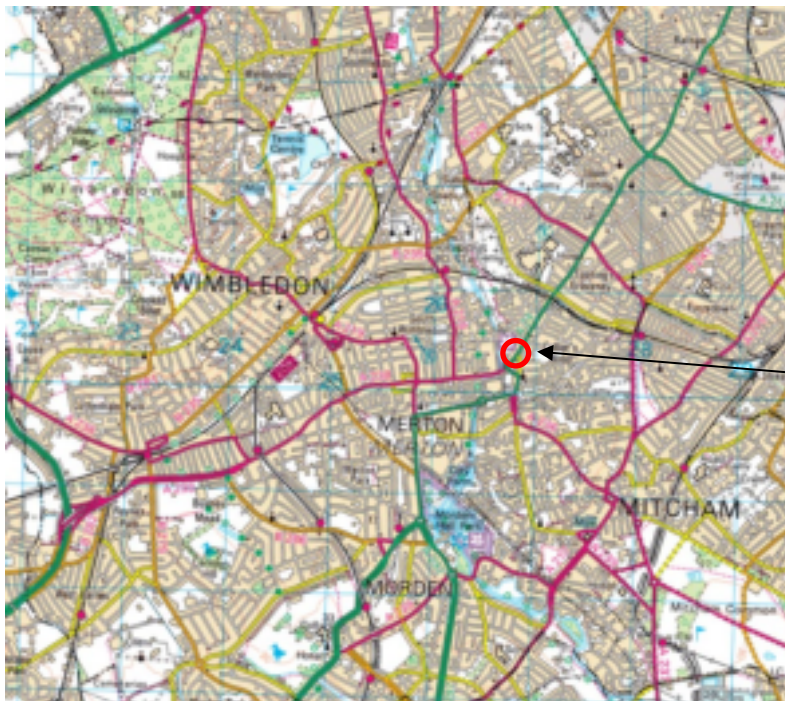
The site is located at the Holiday Inn Express on Colliers Wood High Street in Wimbledon South, London SW19 2BH. The Ordnance Survey Grid Reference for the approximate centre of the site is 526746, 170332. A site location plan is presented in Figure 1.

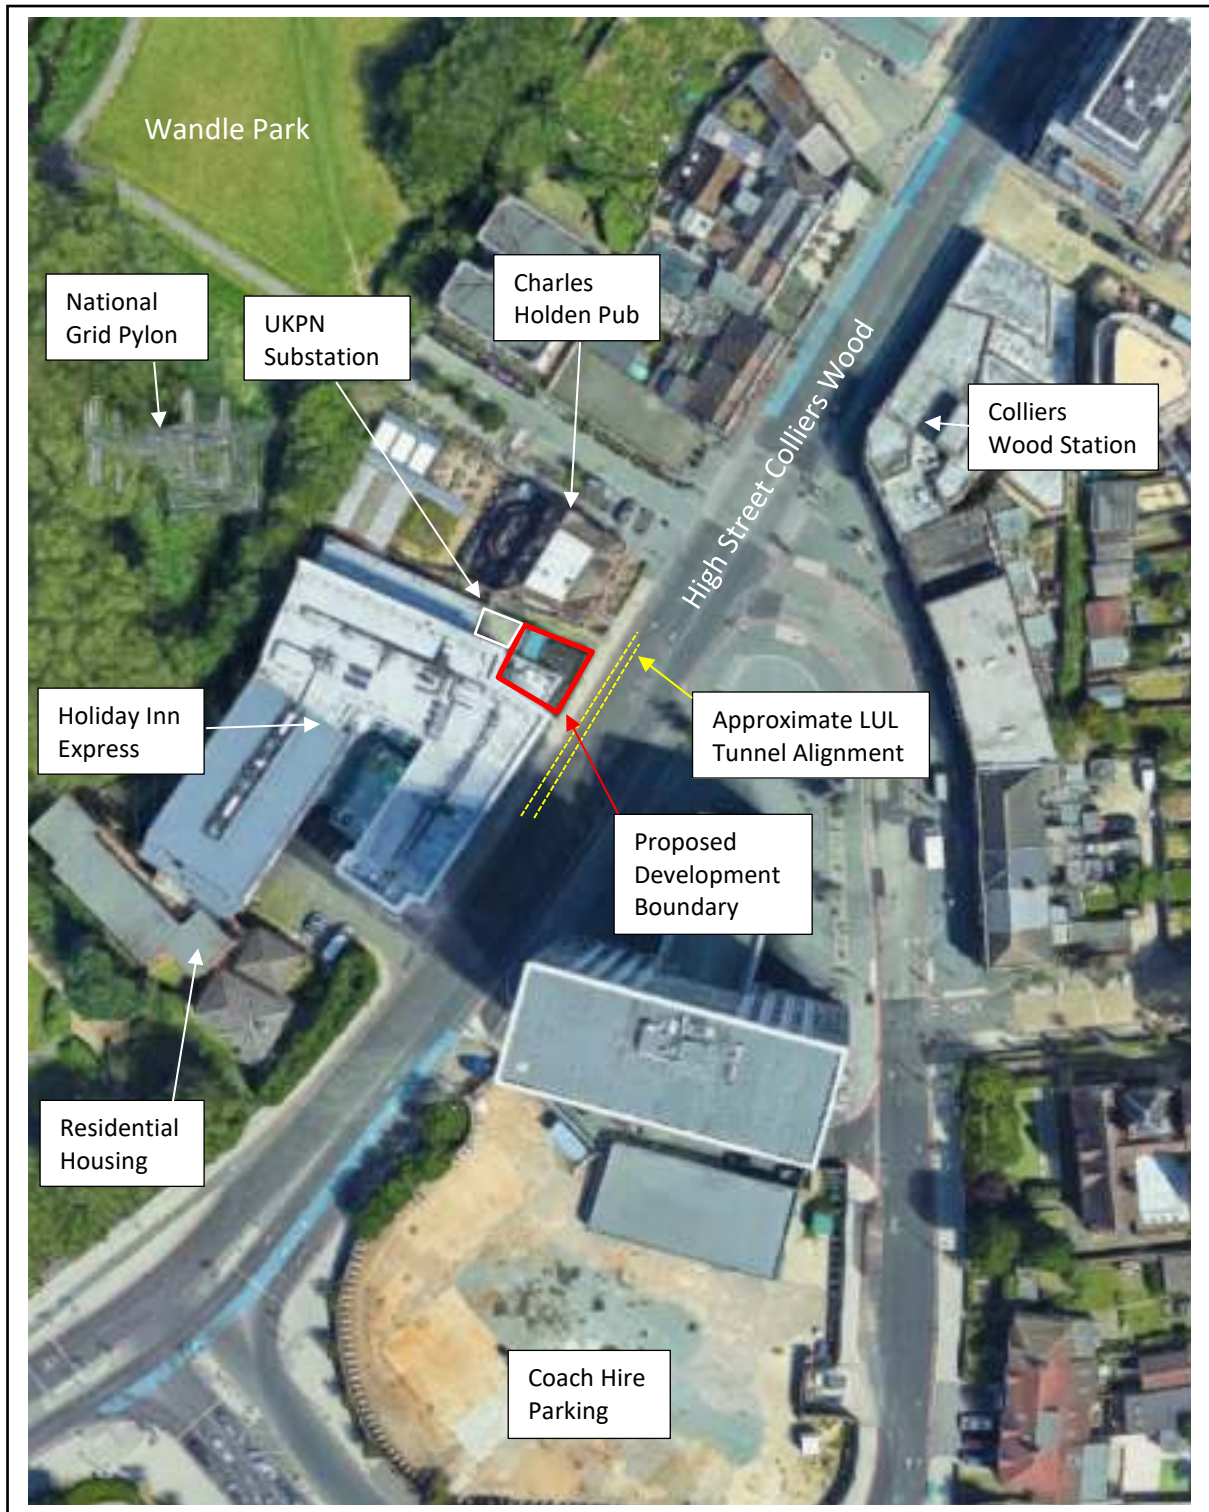
<p>Title</p> <p><b>Site Layout Plan</b></p>	<p><b>Figure 2</b></p>

A site layout plan is included within Figure 2.

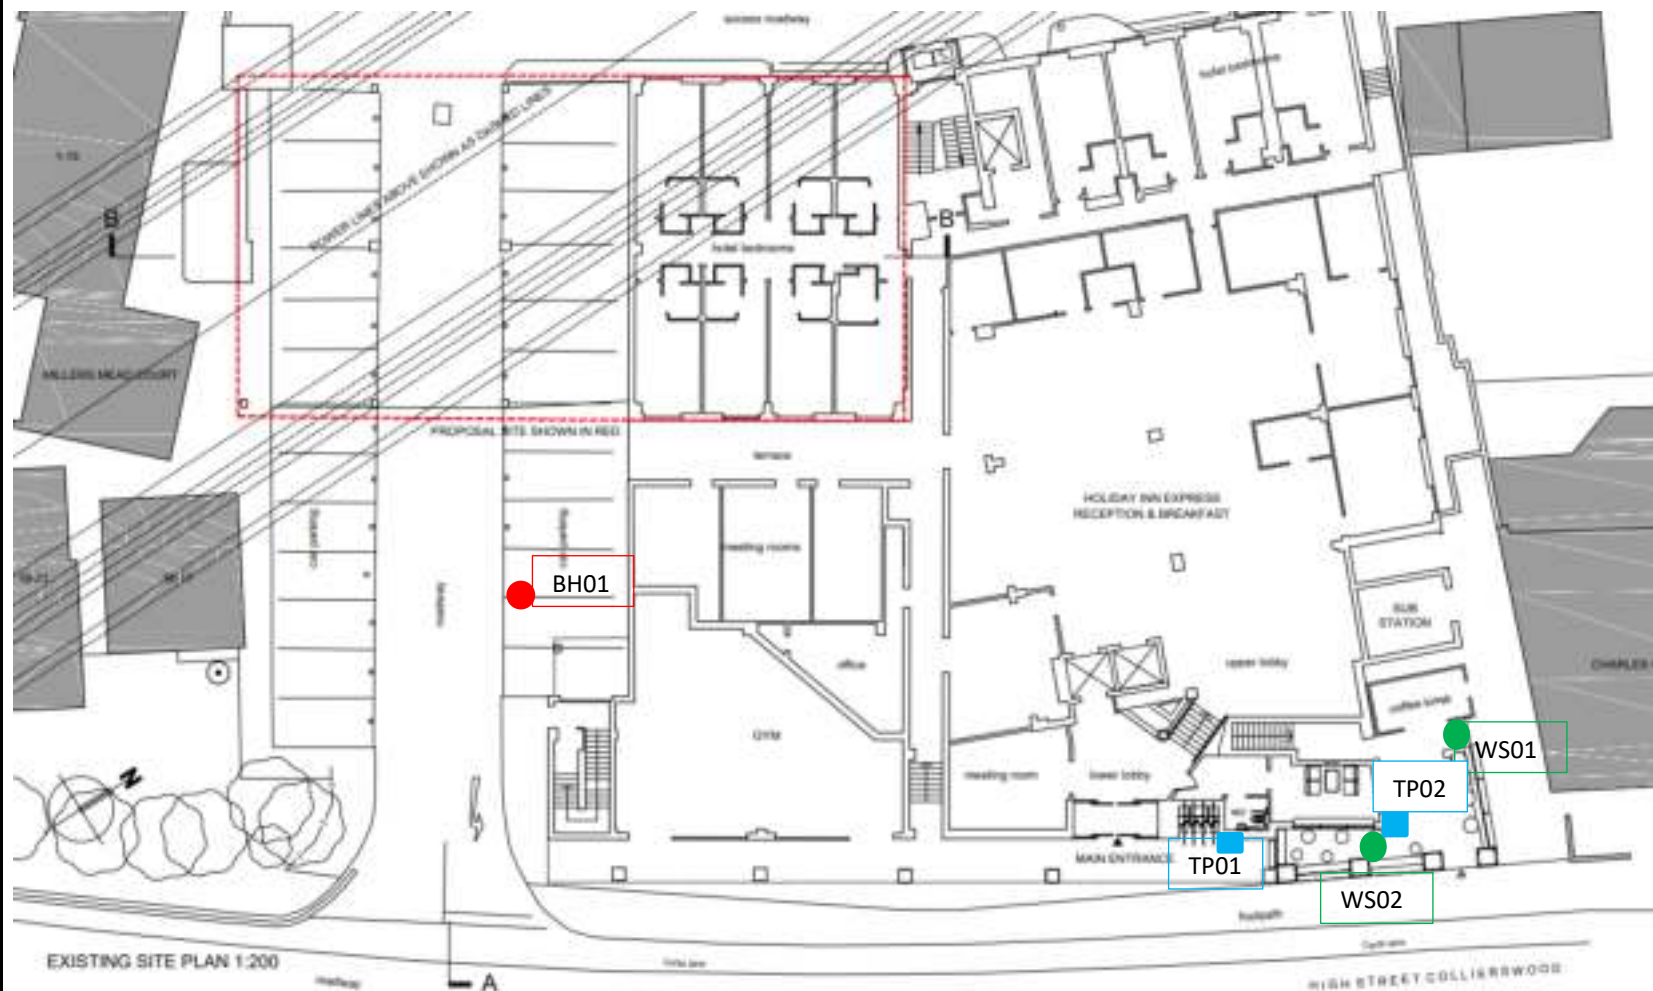
Hand dug trial pits were completed to determine the dimensions and condition of the footings at the three walls within the proposed development footprint. The locations of the trial pits are presented alongside the WS borehole locations on the Exploratory Hole Location Plan (EHLP) in Figure 4.

An exploratory hole location plan is included as Figure 4. The borehole logs from both CGL investigations are included in Appendix G.

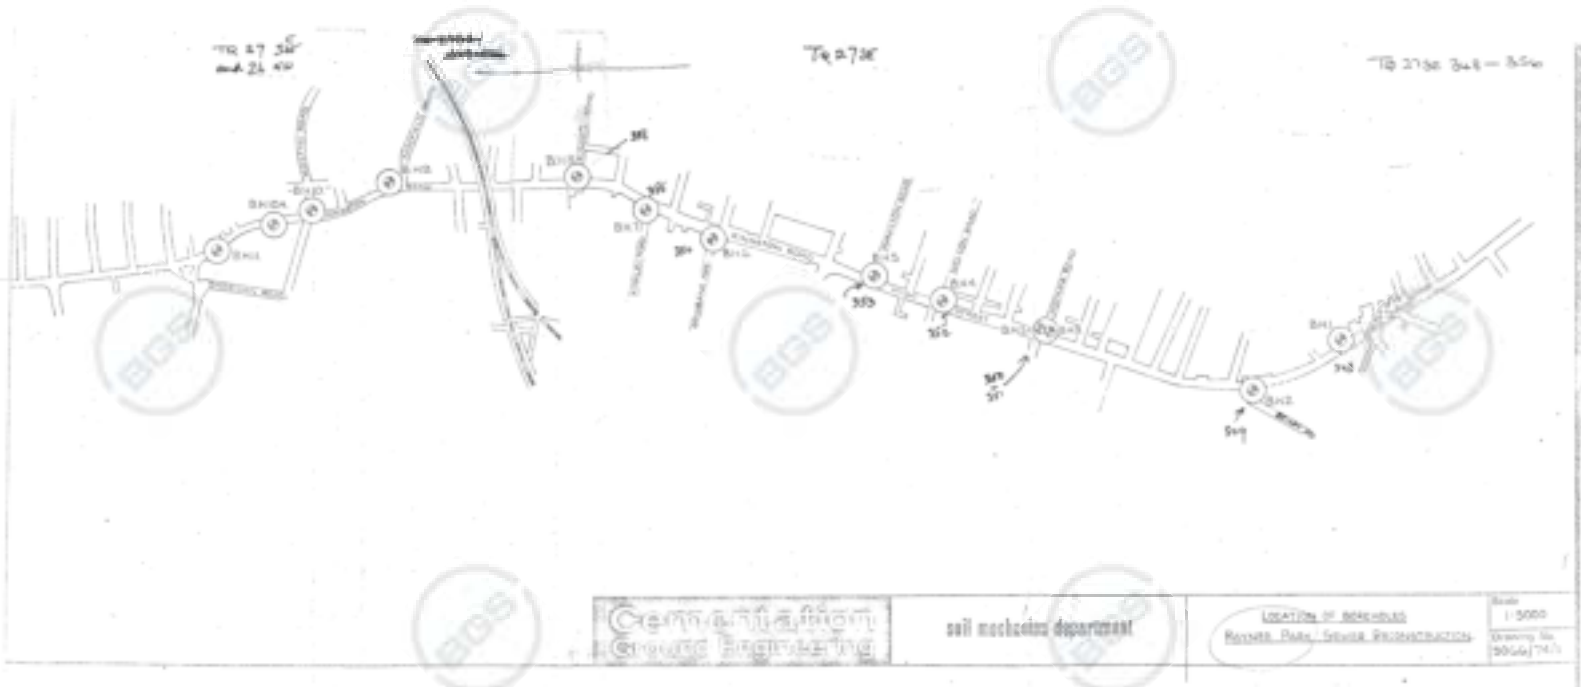
*incorrect location on 1:10560 maps* **TQ 27SE/348**

RAYNES PARK SEWER RECONSTRUCTION

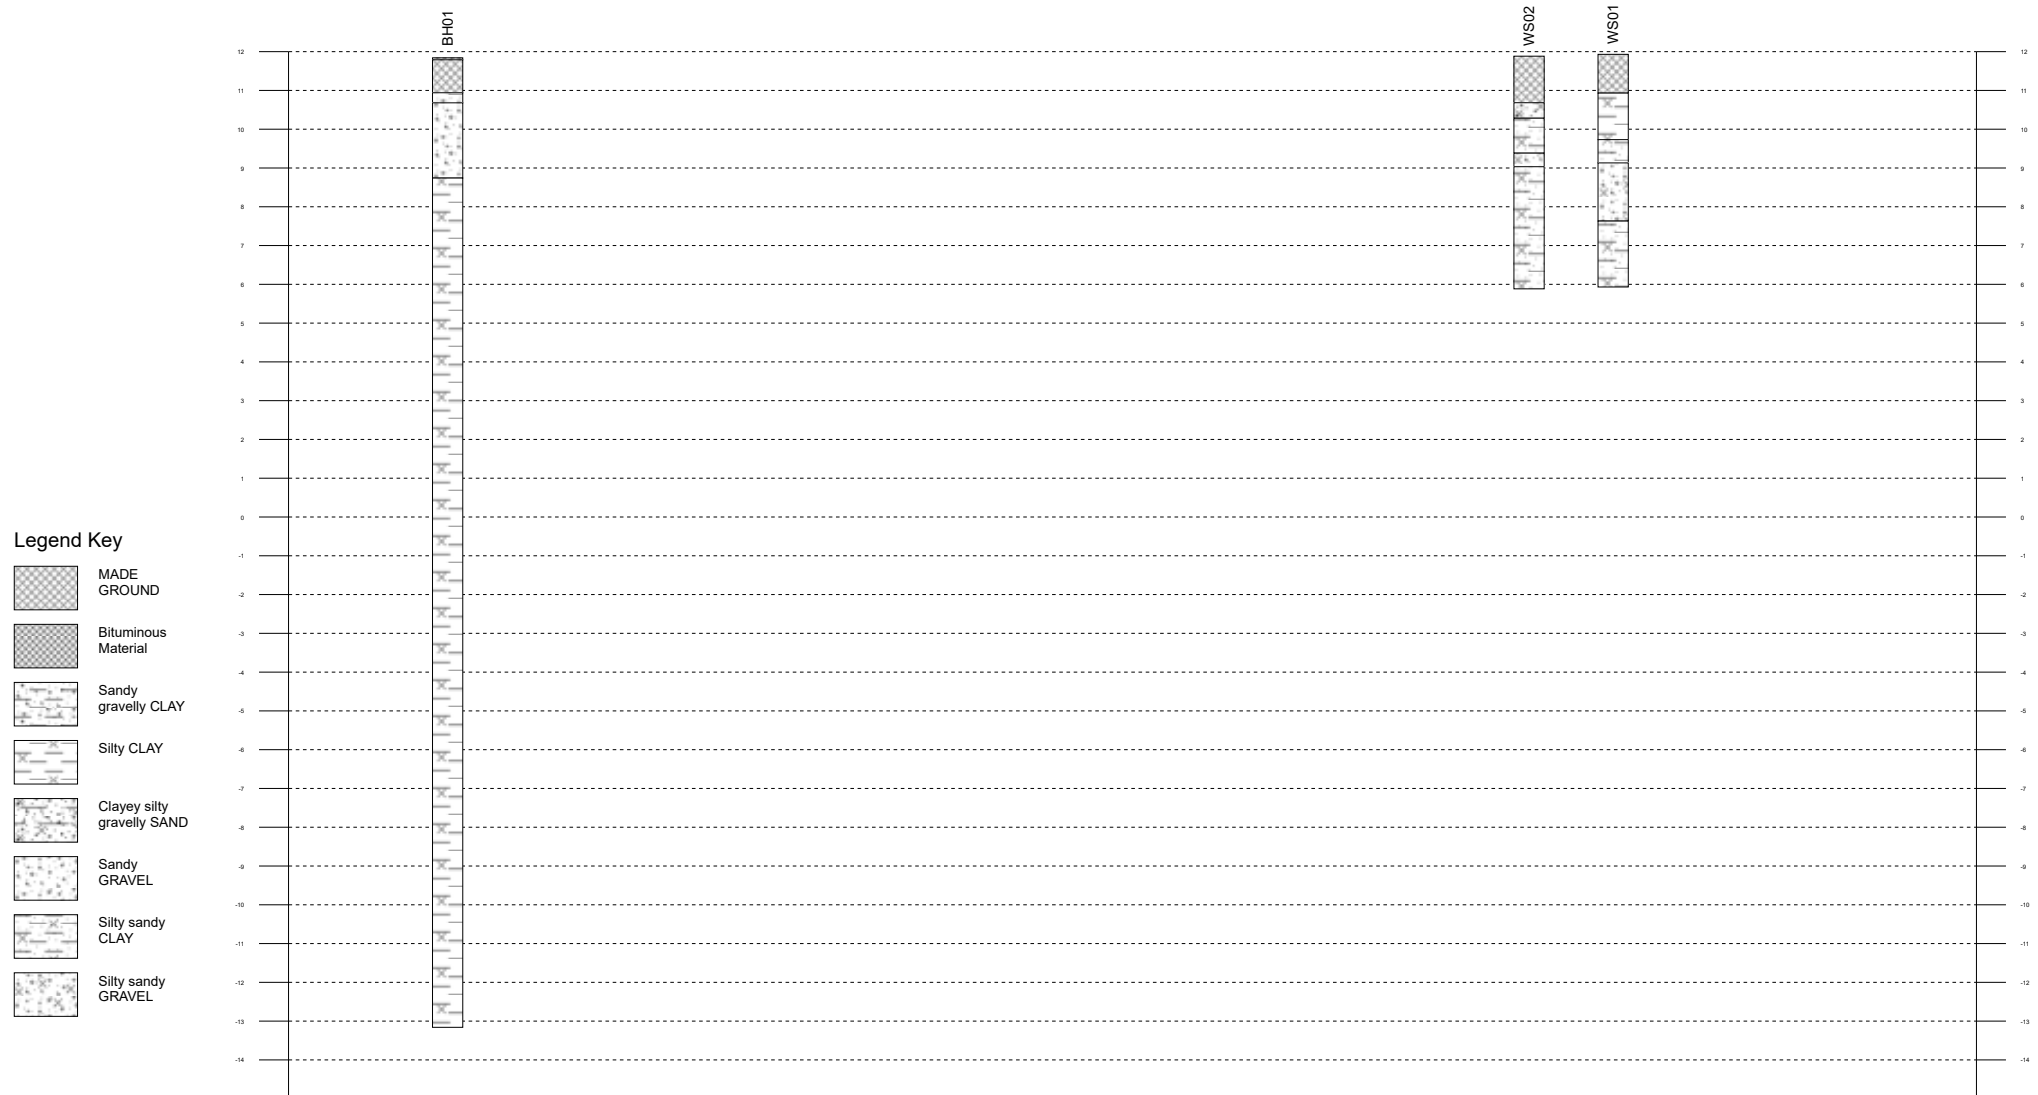
Chainage (m)	0.00	3.56						
Elevation (mAOD)		11.840		42.60	45.63		50.94	
Offset (m)		0.29		4.24	1.11			
				3.56	11.2094			
				42.60	45.63			
				43.06
