HOLIDAY INN EXPRESS, WIMBLEDON

*Geotechnical and Geoenvironmental
Interpretive Report*

Ref. CGL-10060B-GGIR-0001-P00

November, 2024

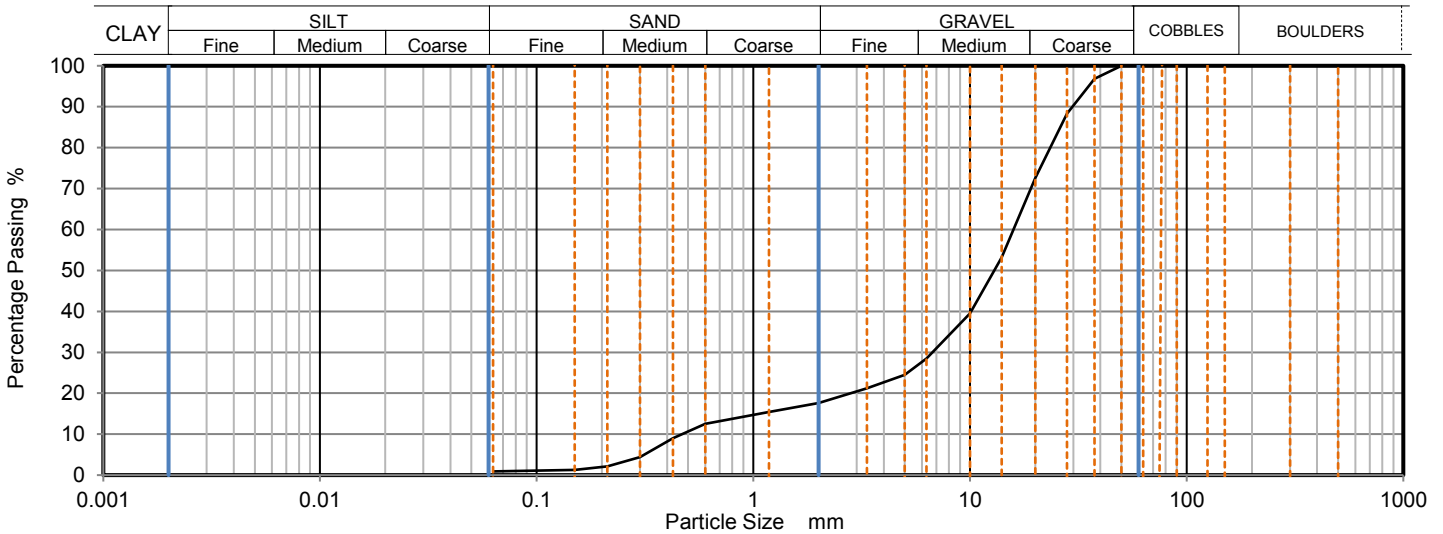
Depth Top [m]: 2.20
Depth Base [m]: Not Given
Sample Type: B

Sieving		Sedimentation	
Particle Size mm	% Passing	Particle Size mm	% Passing
500	100		
300	100		
150	100		
125	100		
90	100		
75	100		
63	100		
50	100		
37.5	97		
28	88		
20	73		
14	53		
10	40		
6.3	29		
5	25		
3.35	21		
2	18		
1.18	15		
0.6	13		
0.425	9		
0.3	4		
0.212	2		
0.15	1		
0.063	1
